**Duke University
Rubenstein Rare Book & Manuscript Library
Treatment Report**

Artifact Number: HTRENT0019

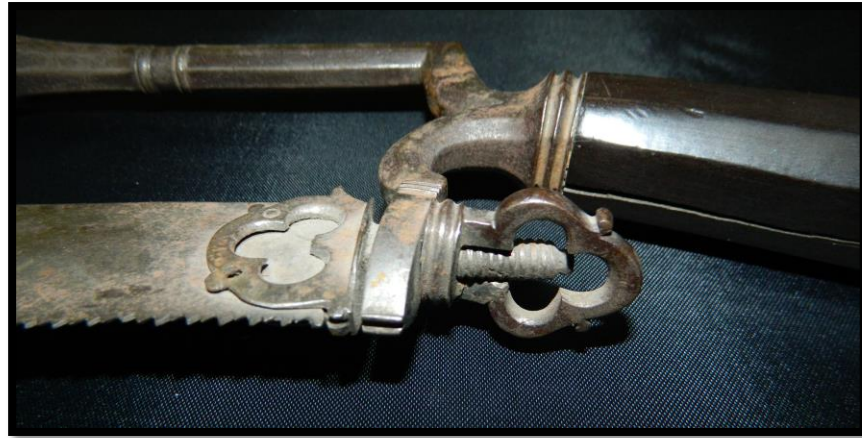
Figure 4: Detailed view of the tightening screw and blade configuration. Note the layer of brown corrosion over the iron surfaces.

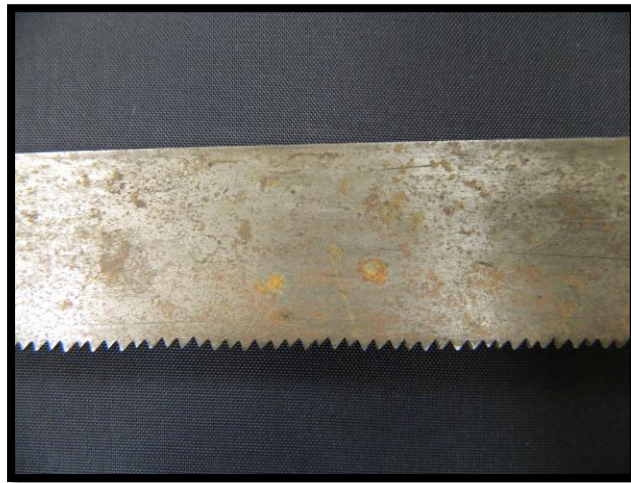
Figure 5: Detailed view of the light layer of corrosion on the saw blade.

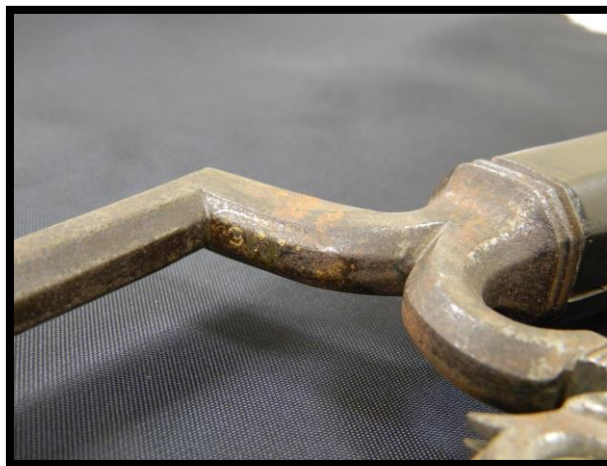
Figure 6: Detailed view of the frame demonstrating the light layer of corrosion on the iron surfaces.

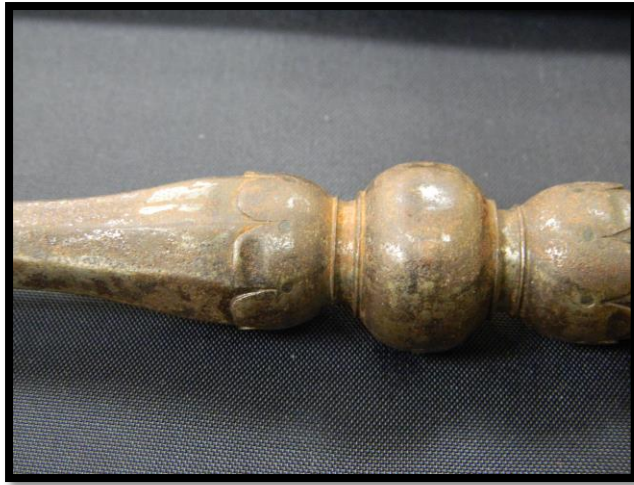
Figure 7: Detailed view of the decorative area on the frame demonstrating the light layer of corrosion on the iron surfaces.

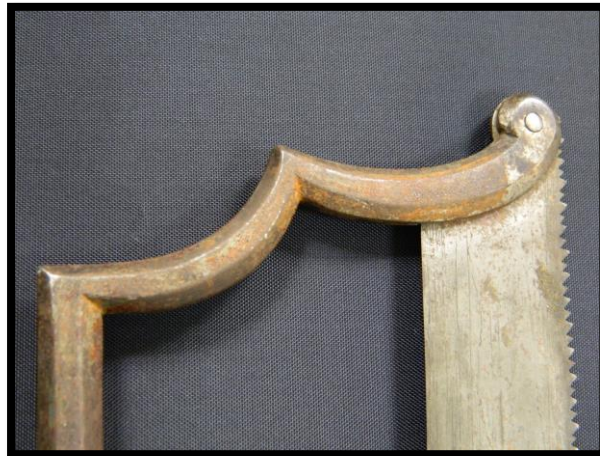
Figure 8: Detailed view of the decorative area on the frame demonstrating the light layer of corrosion on the iron surfaces.

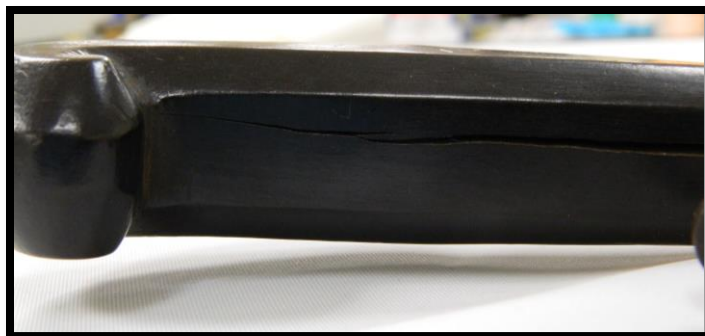
Figure 9: Detailed view of the wooden handle demonstrating the large crack on the interior.

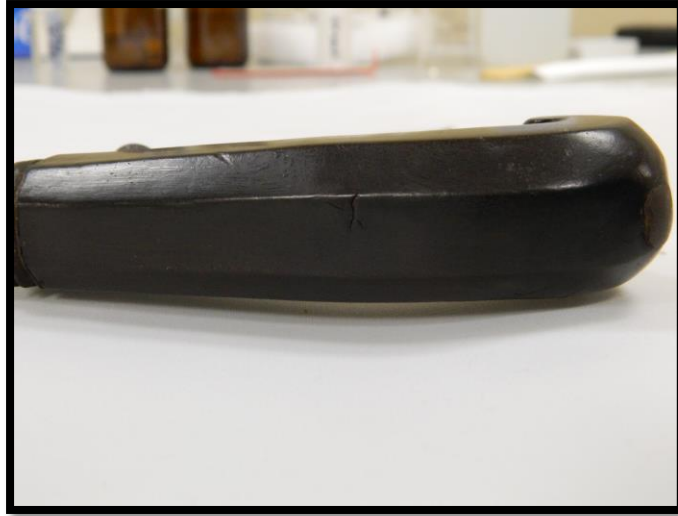
Figure 10: Detailed view of the wooden handle showing marks on the exterior surface.

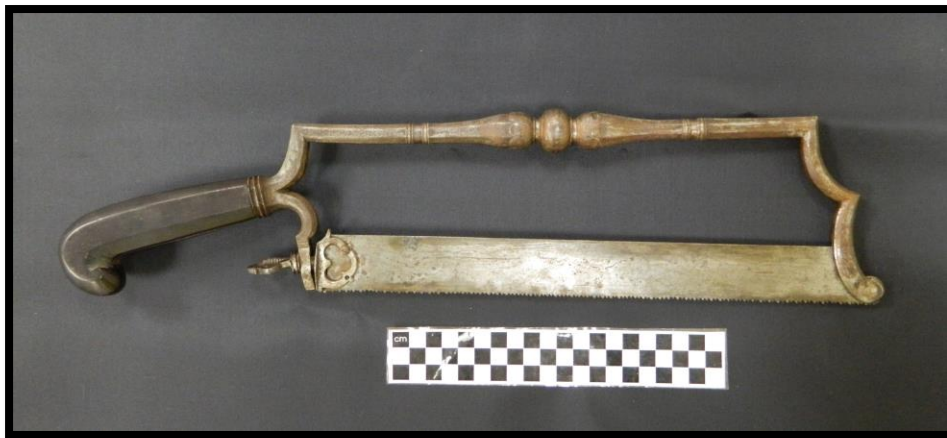
Figure 11: After treatment obverse view of HTRENT0019.
